# Cobra SPX 5300 Audio Dial Replacement

Replace your audio dial if you are having problems with audio distortion in the Cobra SPX 5300.

This guide will walk you through replacing the audio dial.

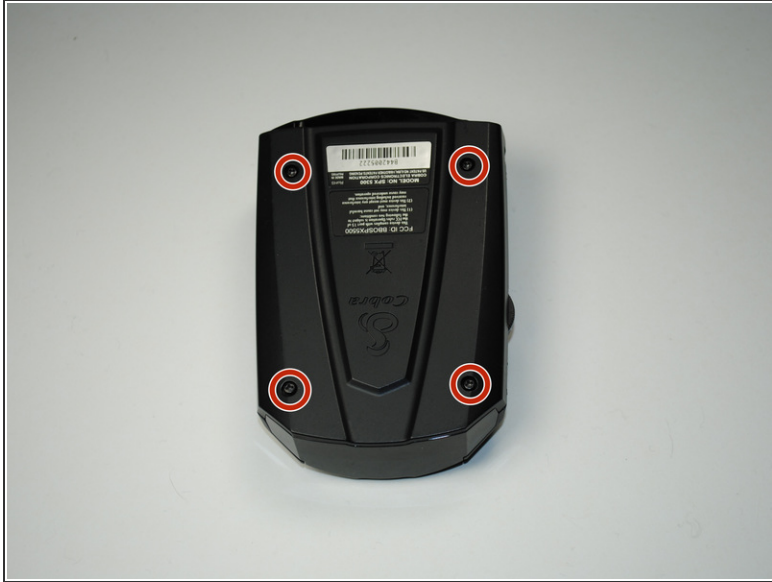
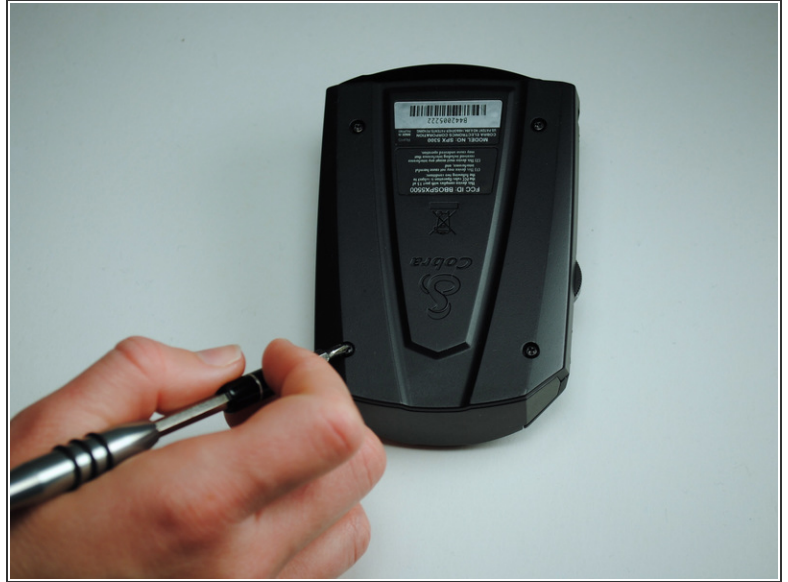
## Step 1 — Windshield Bracket Mount

- Remove the four 9.5 mm Phillips #0 screws from the back of the device.

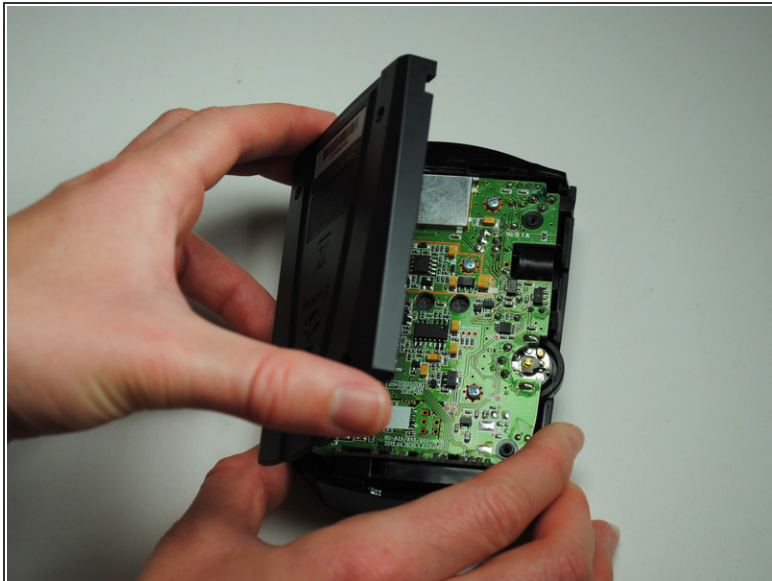
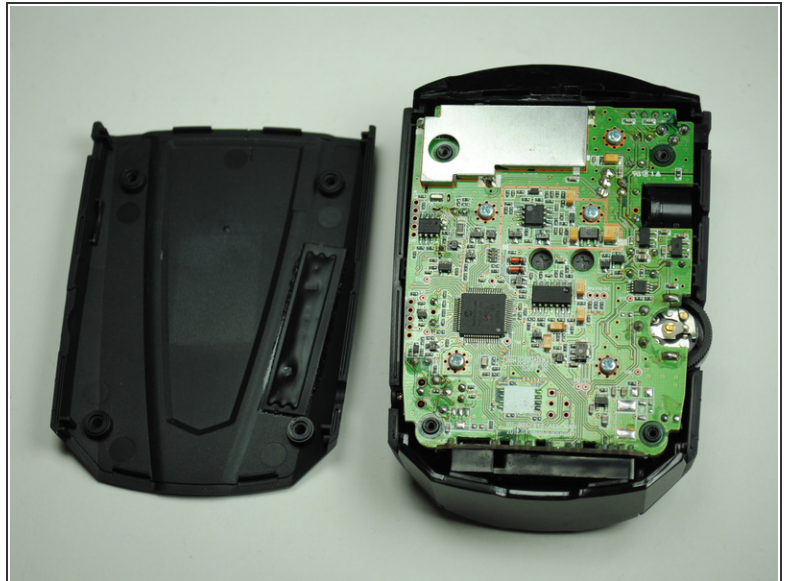
## Step 2

- Pull the black plastic back case off of the device.

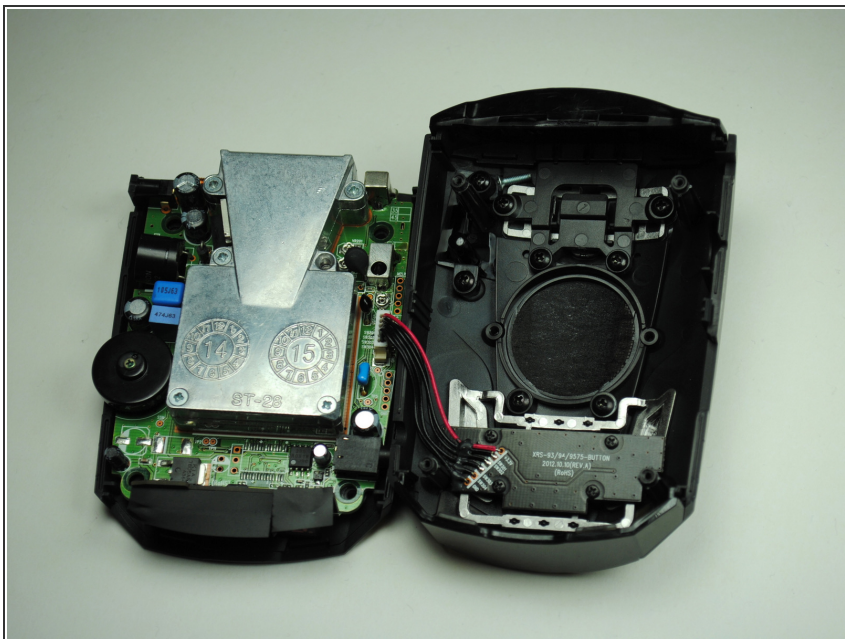
## Step 3

- Lift up the motherboard and lay it flat next to the device.

⚠ Be careful not to sever the wires. The buttonboard is connected to the motherboard by the wires.

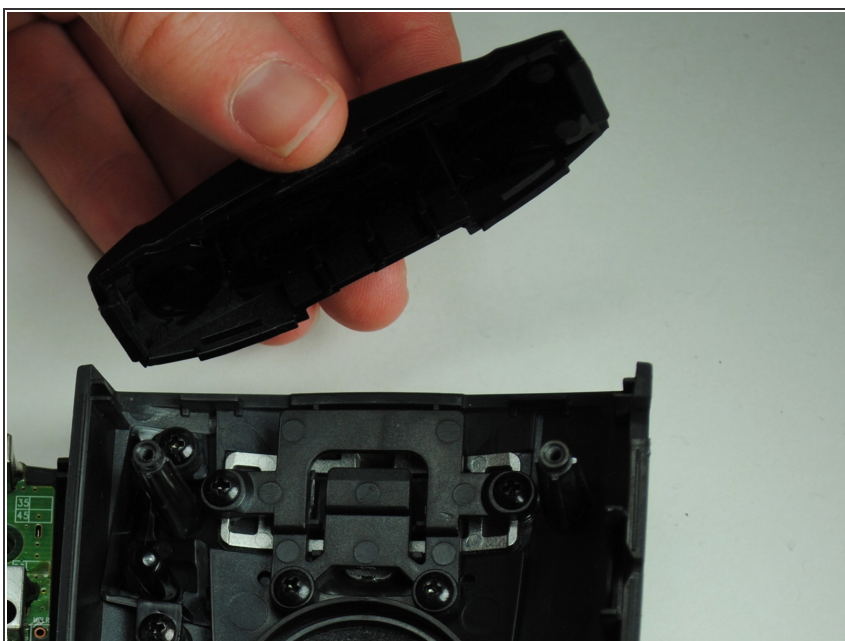
## Step 4

- Remove the windshield bracket mount.

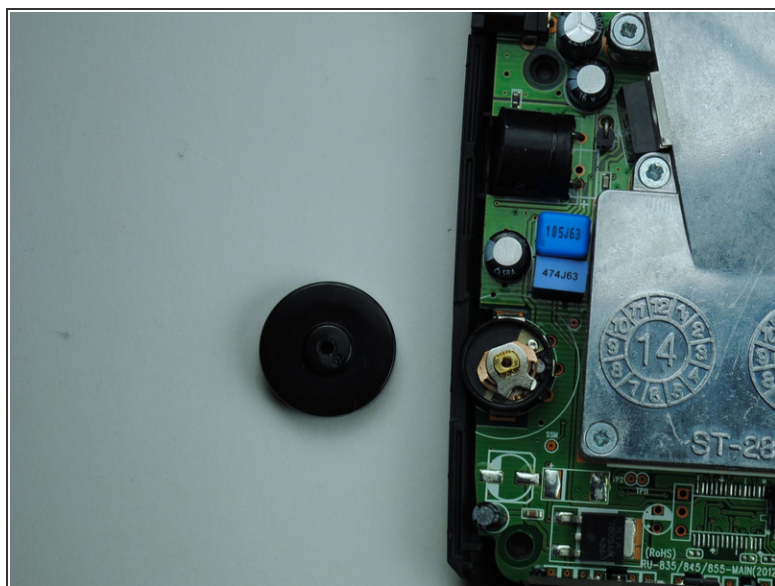
## Step 6

- Remove audio dial.

To reassemble your device, follow these instructions in reverse order.
